NCAT FORENSICS

Section N7 contributes to silo storage recommendations, RAP content suggestions

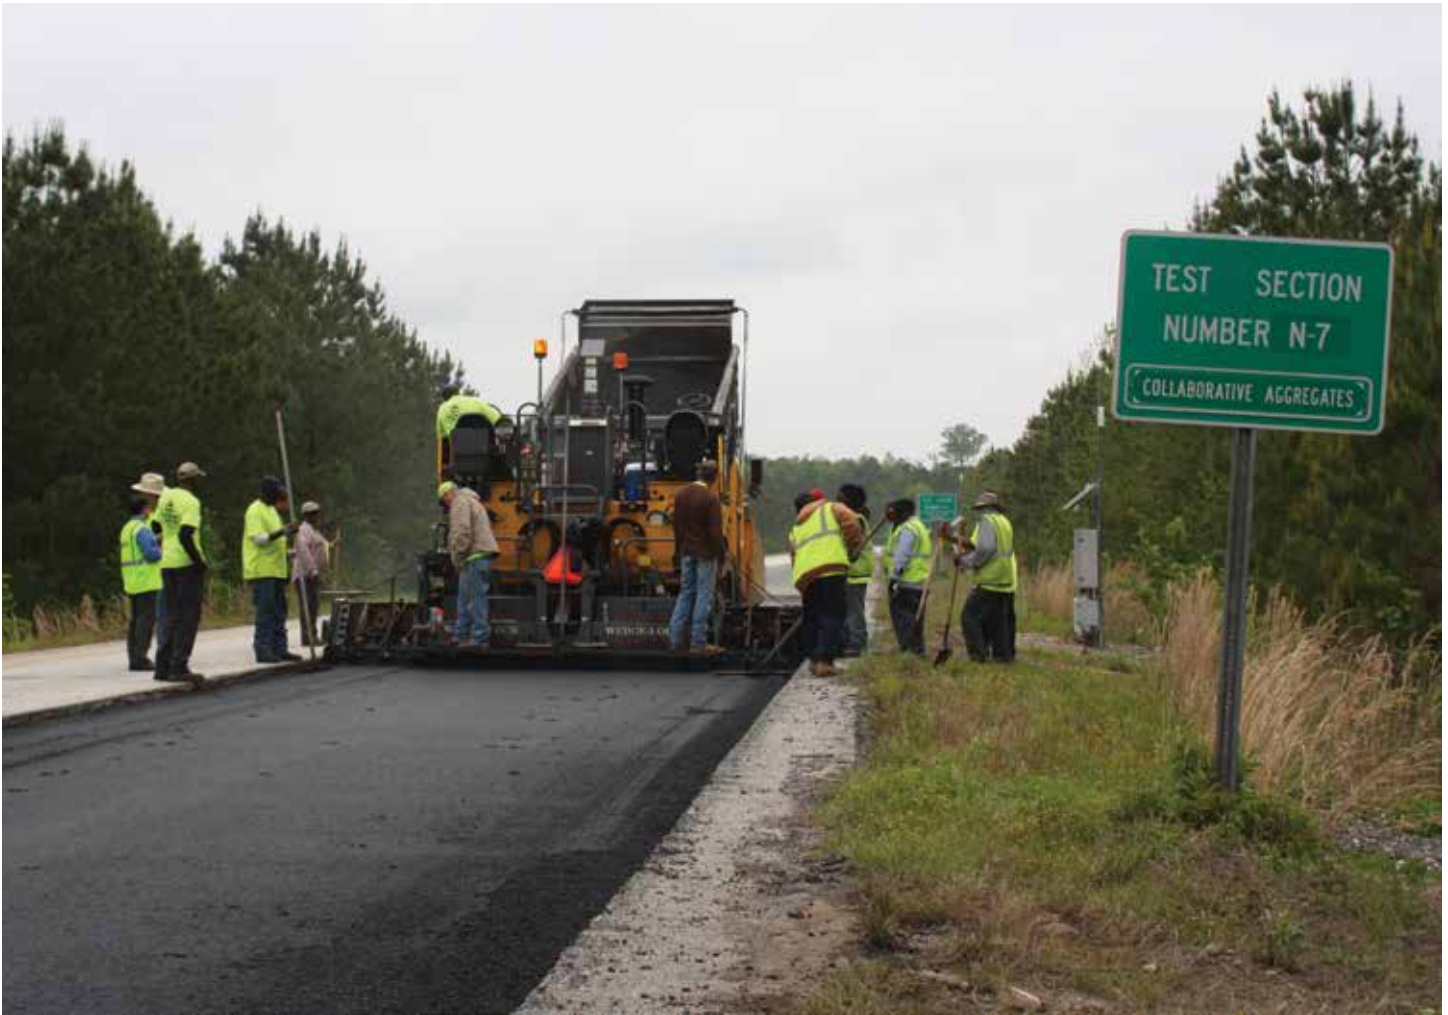
Here we see the crew installing the experimental asphalt pavement for section N7 on the NCAT test track in the summer of 2015. The 1.5-inch surface course included the Delta S rejuvenator.

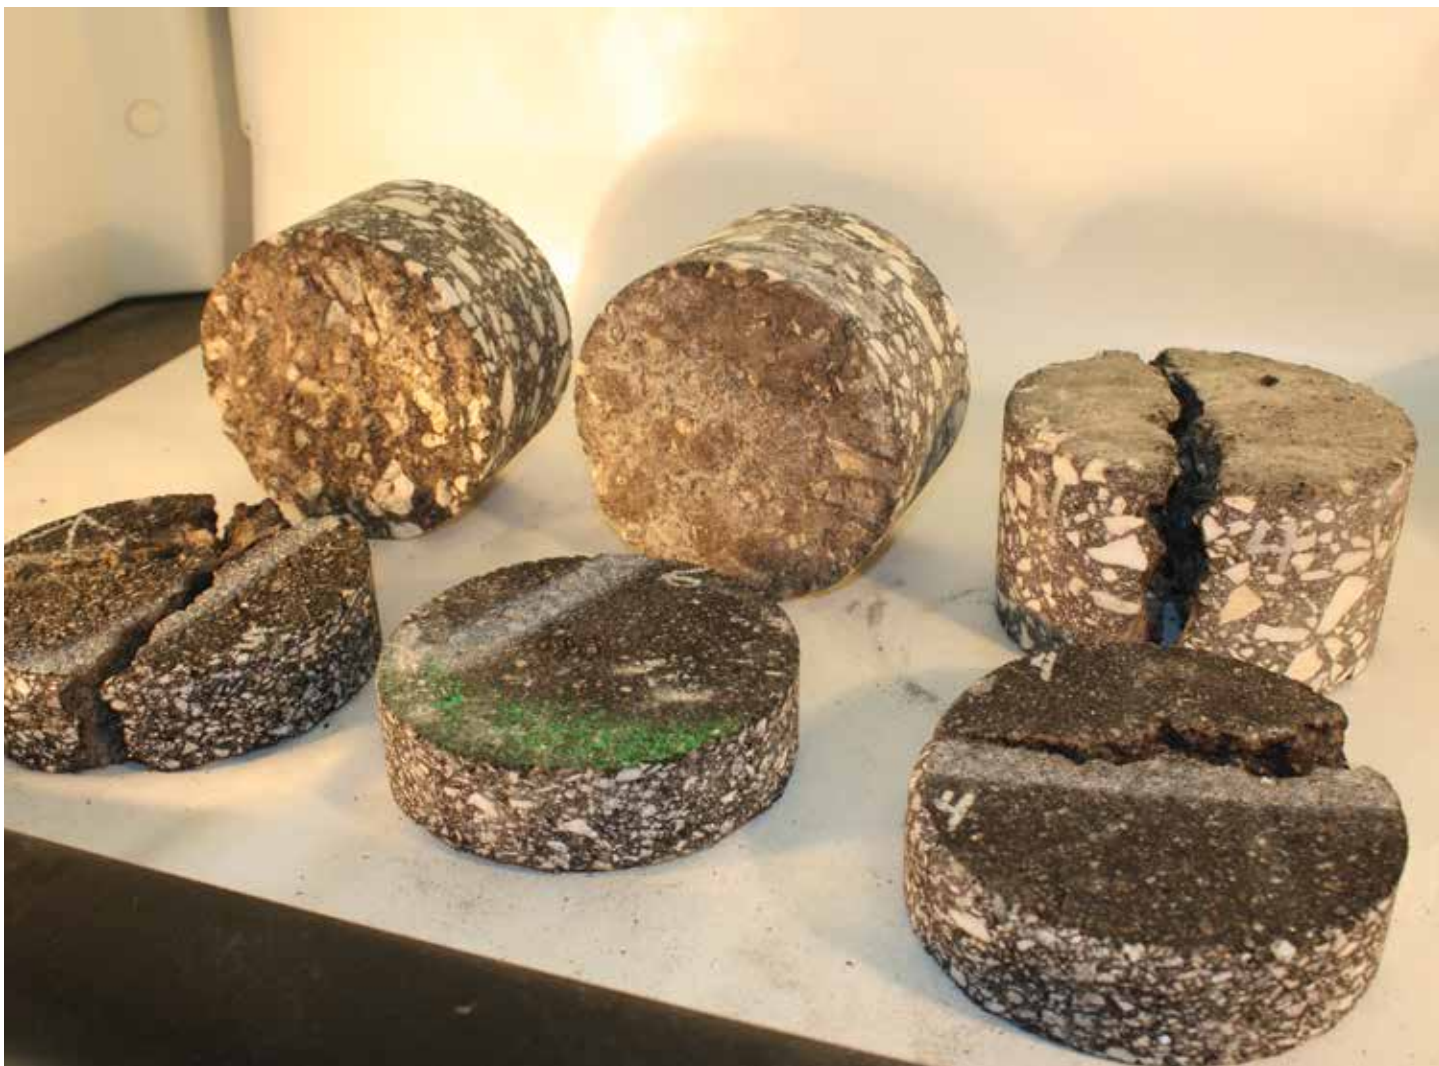
These core samples are from the original failed N7 pavement section.

NCAT staff noticed cracking in the wheel path of N7. In March, they took full-depth cores of the entire 6-inch pavement structure in between the wheel paths in an uncracked area to determine bond strength between

Surprisingly, all three cores were found to be de-bonded, i.e., the wearing course is delaminated from the underlying layers. NCAT allowed traffic to continue for a short time but suspended it when existing cracks grew larger and new ones appeared. Three additional cores cut on transverse cracks indicated that the intermediate and base layers had been compromised as a result of the de-bonding, meaning the underlying layers had also cracked.

As the forensic investigation continued, the evidence suggested that the cracking problem with N7 was due to de-bonding between the surface course and intermediate layer. NCAT staff suspected the N7 surface mix de-bonded and the CG Section N8 surface mix did not because the N7 mix was slightly leaner (even though volumetrics compared within allowable tolerances).

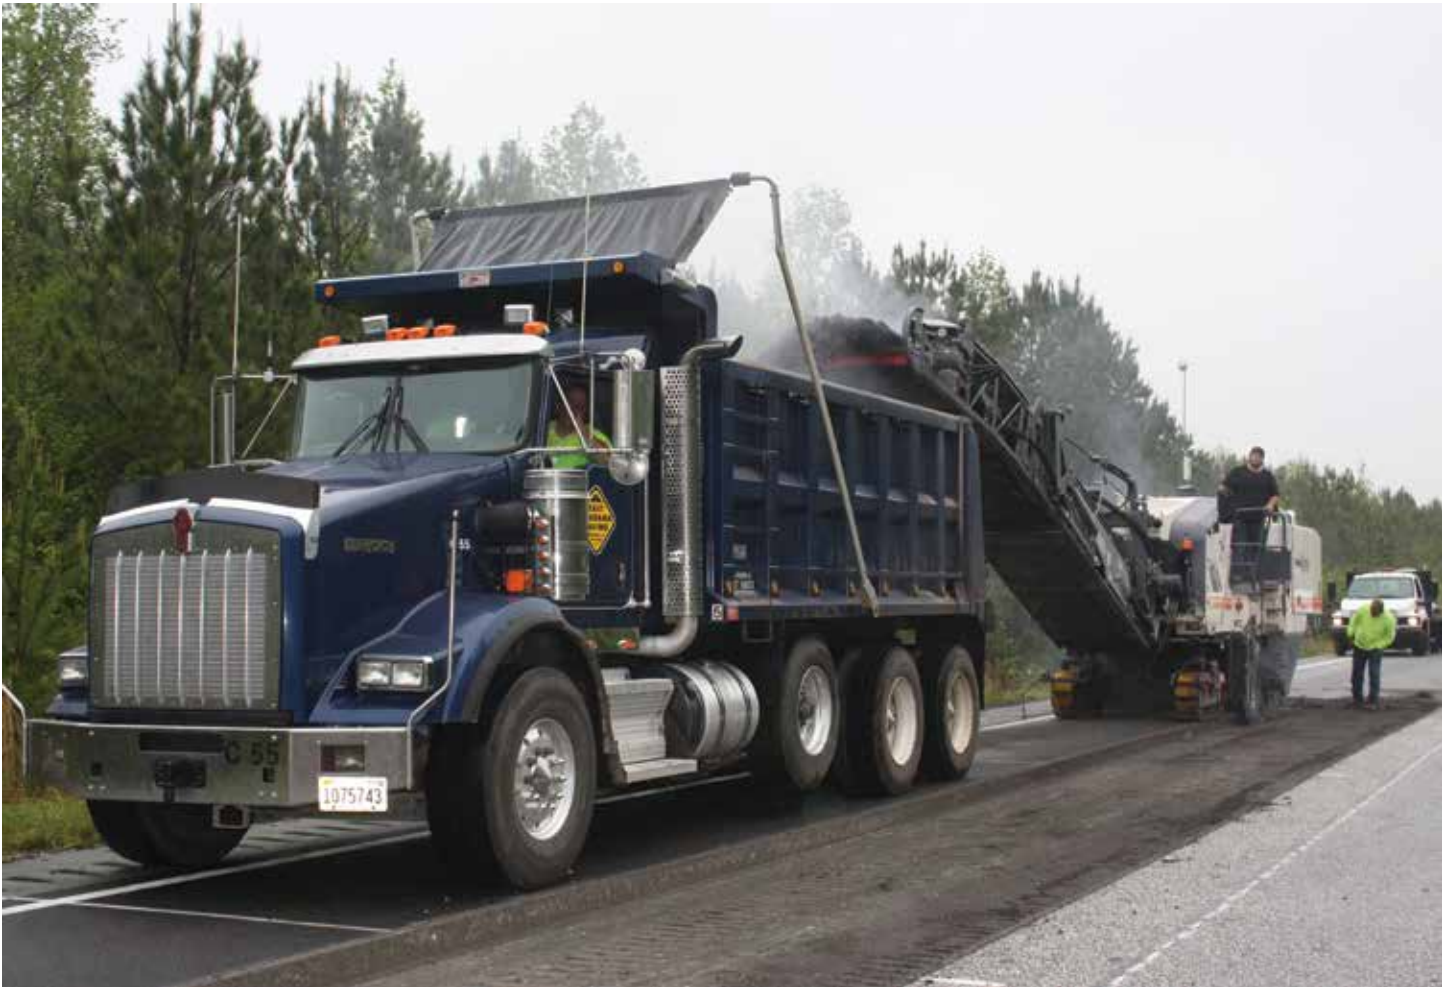
The failed wearing course of N7 was milled off to allow installation of the modified mix, which incorporated a PG67-22 binder, 35 percent RAP with Delta S rejuvenator, and no RAS. The modified mix was allowed extended storage time in the silo to eliminate the possibility of another failure due to reduced mix shear strength. This repair was completed the week of May 9, 2016, and ESAL testing resumed shortly thereafter.

The final fix for N7 involved replacing the wearing course with a mix design identical to the surface mix of CG Section S5, which contains 35 percent RAP and no RAS. Furthermore, CG Section S5 incorporates a PG58-22 asphalt binder while N7 incorporates a stiffer, PG67-22, and Delta S rejuvenator.
